From: Miller, Garyg
Sent: Saturday, September 9, 2017 9:14 AM
To: Sanchez, Carlos; Coltrain, Katrina; Coats, Janetta; Peterson, Mary
Cc: Meyer, John; Edlund, Carl; Opalski, Dan; Gray, David; Carroll, Craig
Subject: FW: Final follow up... Inspections of SJRWP - questions

1. How can one state that “the liner is in place” and “we don’t have an indication that the underlying waste materials have been exposed” when you have not been able to completely inspect all portions of the cap?

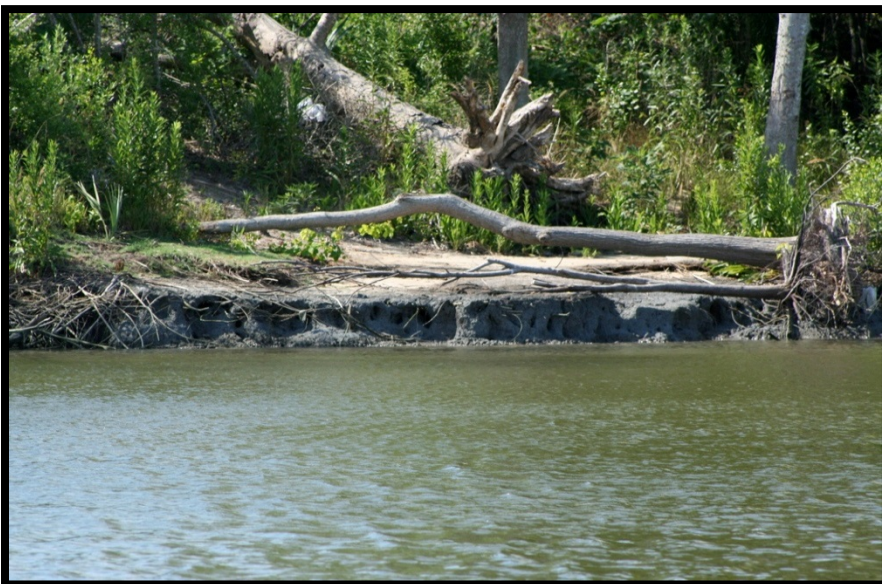
No viscous dark material has been observed on the cap. It is not clear what the image may be showing, but in the past organic material from the river has had a dark appearance. The paper-mill waste in the waste pits generally has a grayish color as seen in the attached photograph taken prior to the installation of the cap.

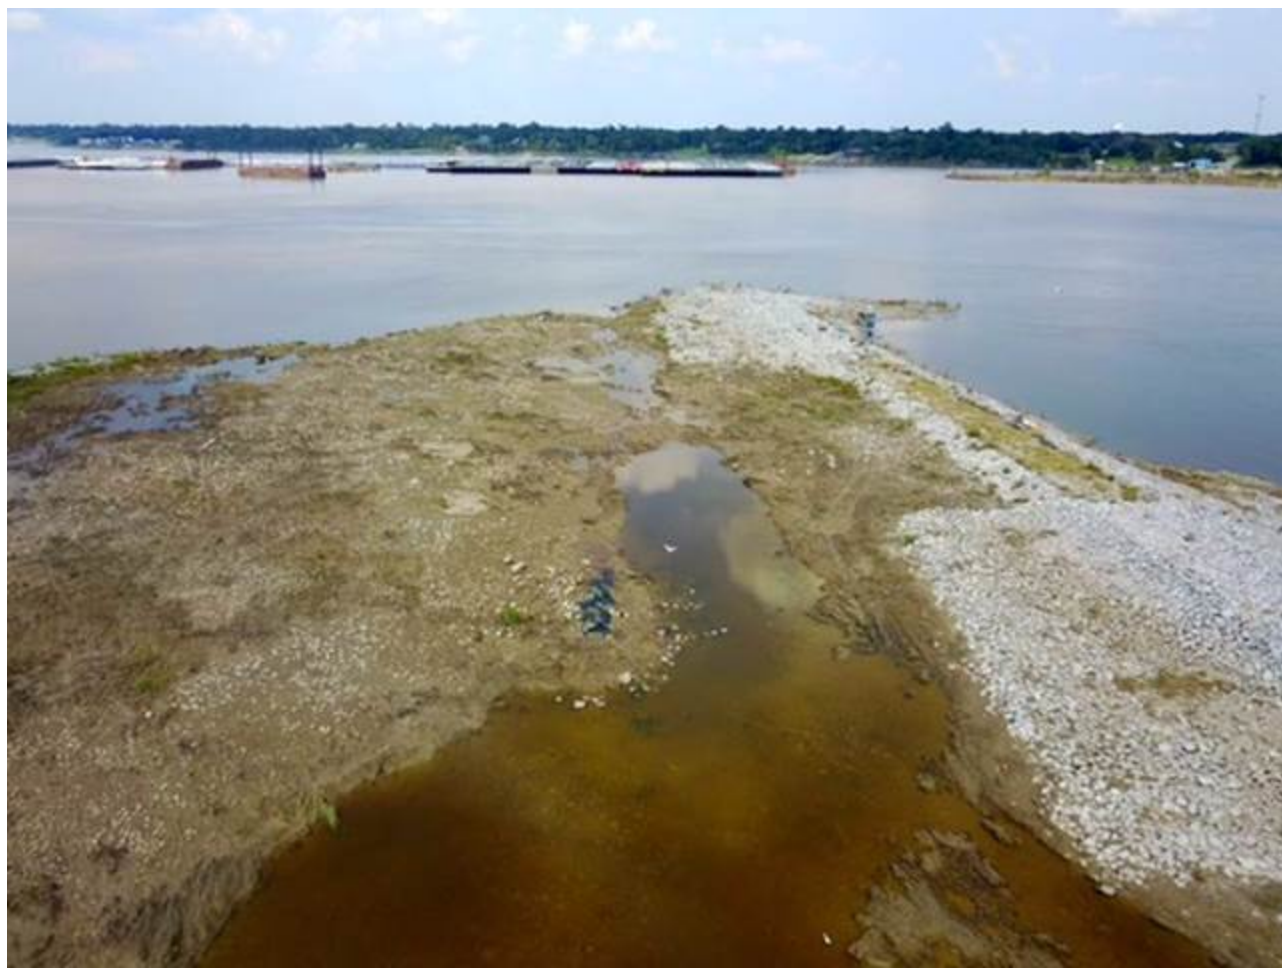
Drone footage from sometime since the weekend captured the attached image. If you look in the middle of the image, you see bluish looking material of some sort. When I first saw it, I thought it was liner, but when I zoom in, it appears to be a viscous bluish material. It's hard to tell.
